Houston Ball Field

Erosion Study Final Report

Chartiers Creek
Houston, PA

Prepared by the West Virginia Water Research Institute

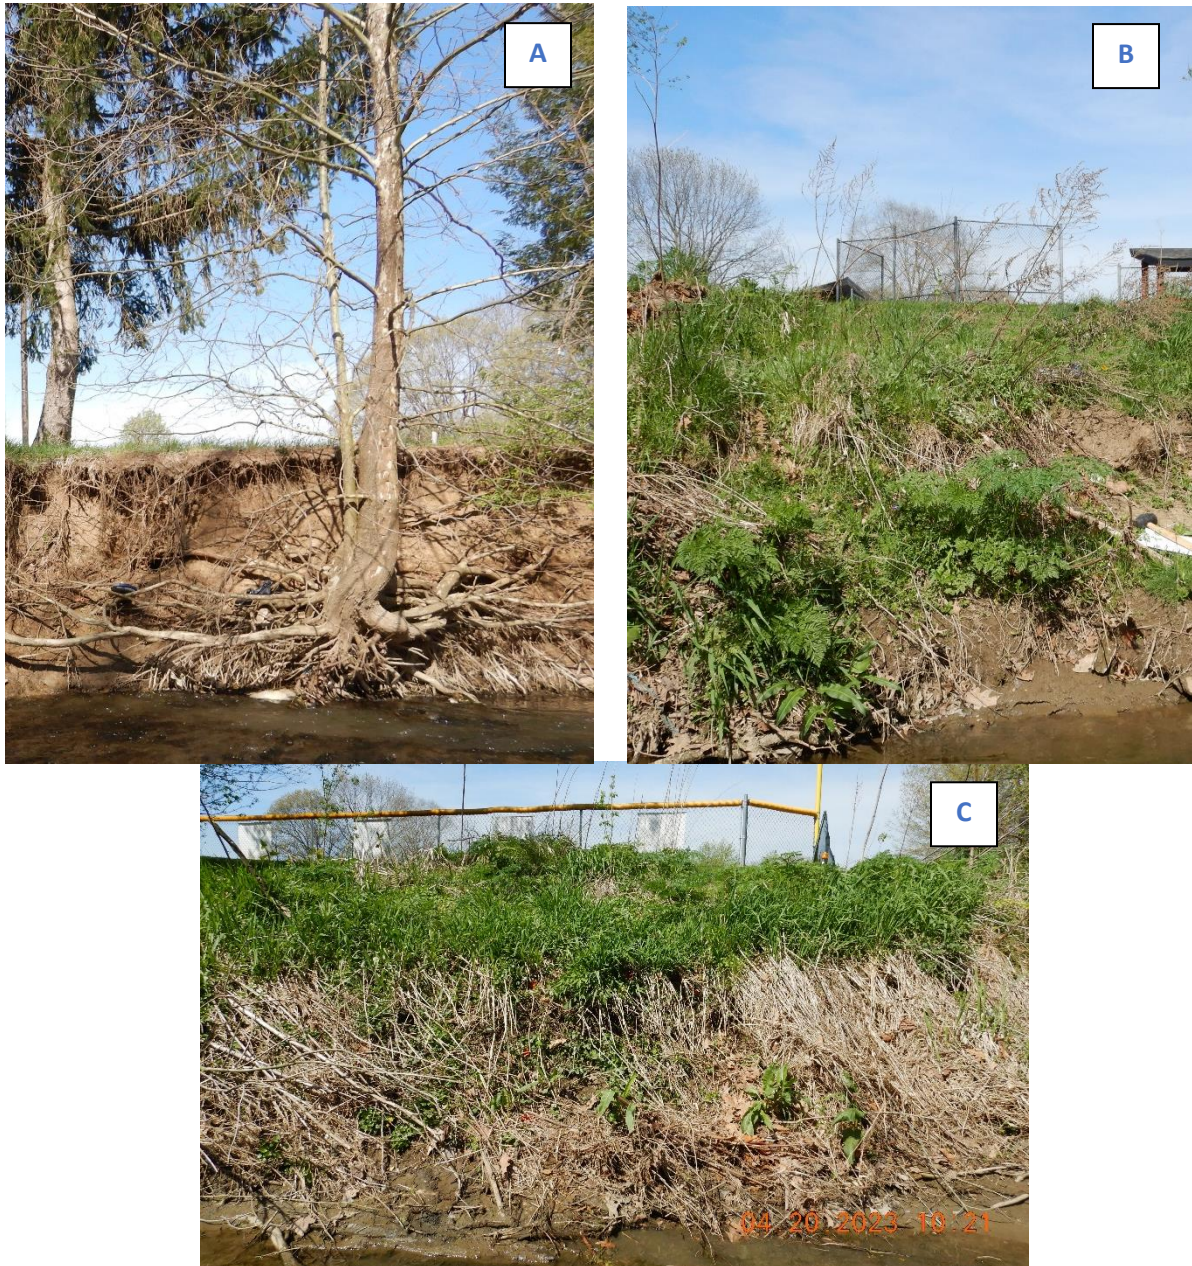
Figure 2. Photos representing the 3 subsections of study, moving downstream from A – C.

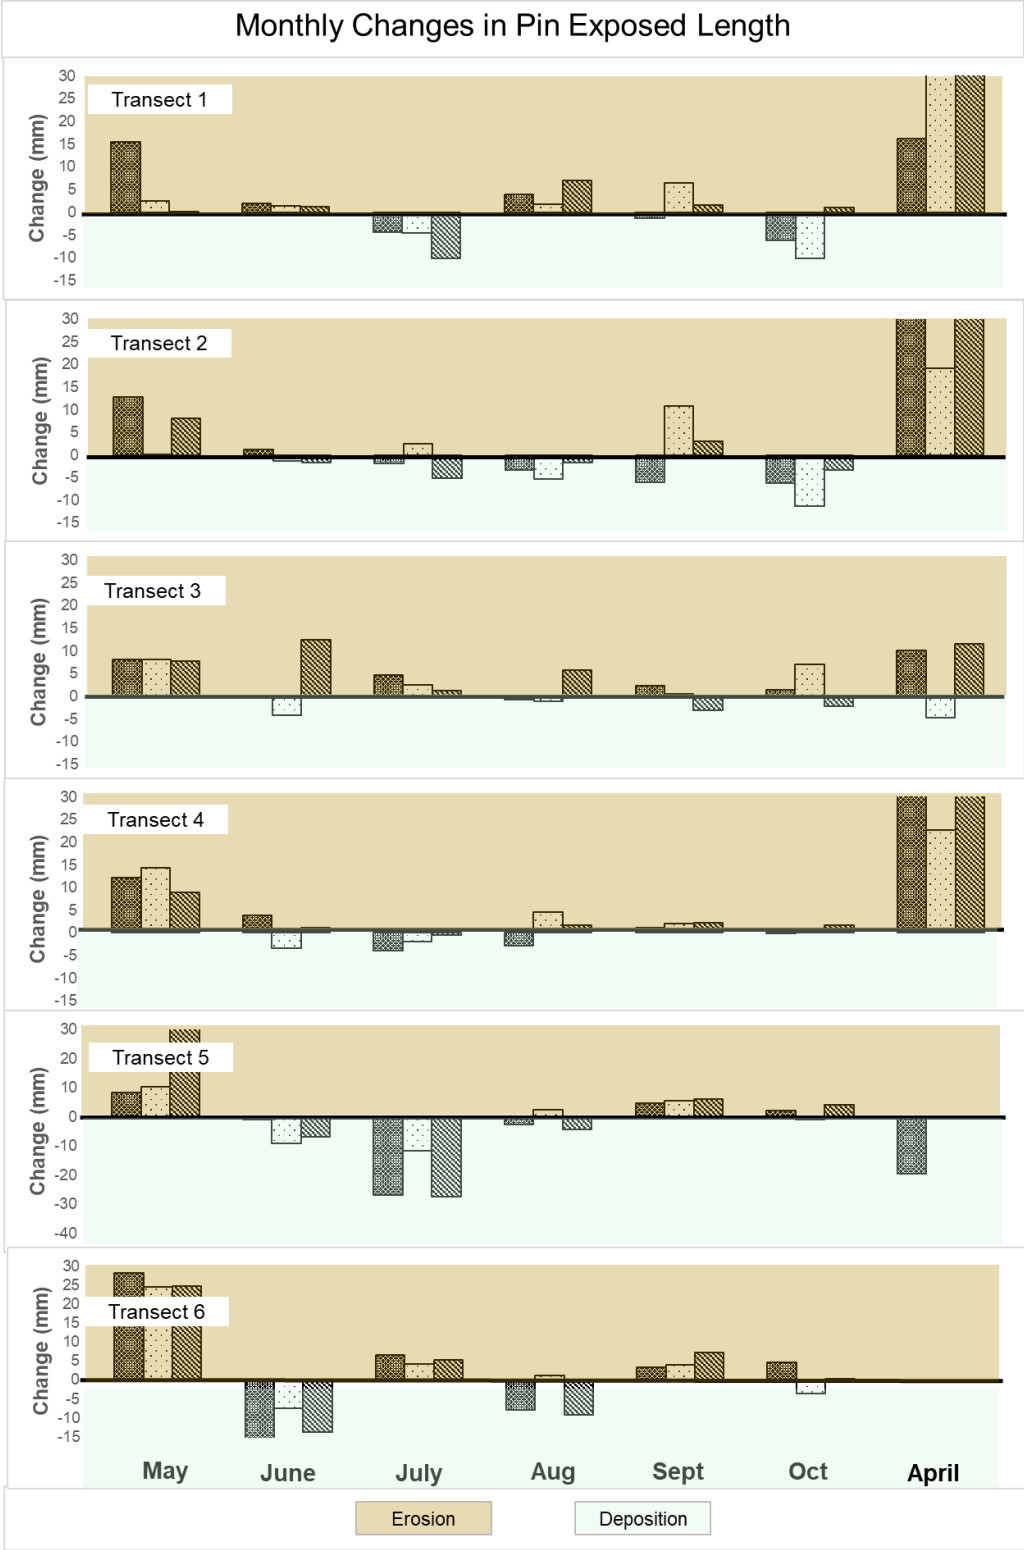
UCCWA collected pin measurements monthly from May through October 2023, and repeated measurement again in April of 2024. The April 2024 sample offers results one year after the pin installation. This took place after a winter of high flows, followed by significant flooding in early spring. During this visit, it was observed that 5 pins had been washed out since the measurements taken in October of 2023. The lost pins were not used in calculating the overall study average since their final measurements were unknown. Results from the monthly measurements are summarized in Figure 6 below, where a positive change (brown) indicates erosion, and a negative change (green) indicates deposition. The most widespread erosion occurred in the spring (April – May 2023) and over the winter (October 2023 – April 2024). The average net erosion among the pins was 7.35 mm over the first 6 months and 33.96 mm over the full length of the study. However, one pin showed as much as 101.29 mm (4 inches) of erosion over the year. Taking the net change in the pin lengths over the year concludes that 10 pins experienced net erosion, 3 pins experienced net deposition, and 5 pins were washed out entirely (Figure 7). Data tables and additional figures can be found in Appendices B-C.

Figure 6. Change in pin exposed length from May 2023 through April 2024 at each of the six transects.

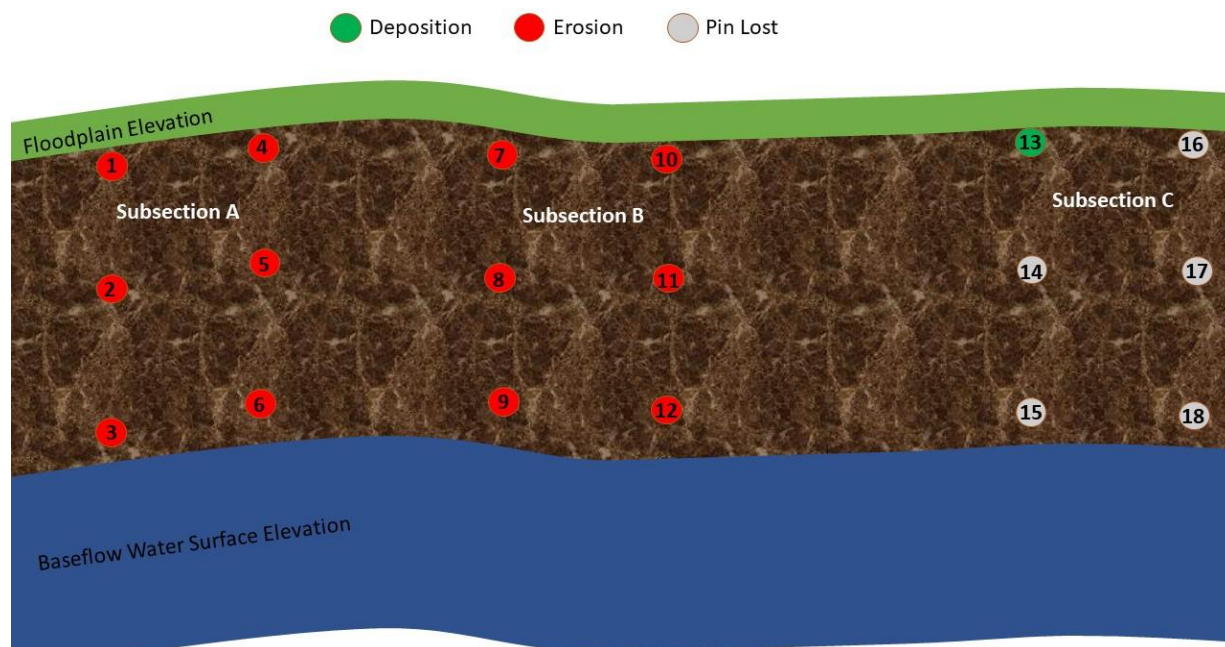
Figure 7. Pin changes one-year post-installation.

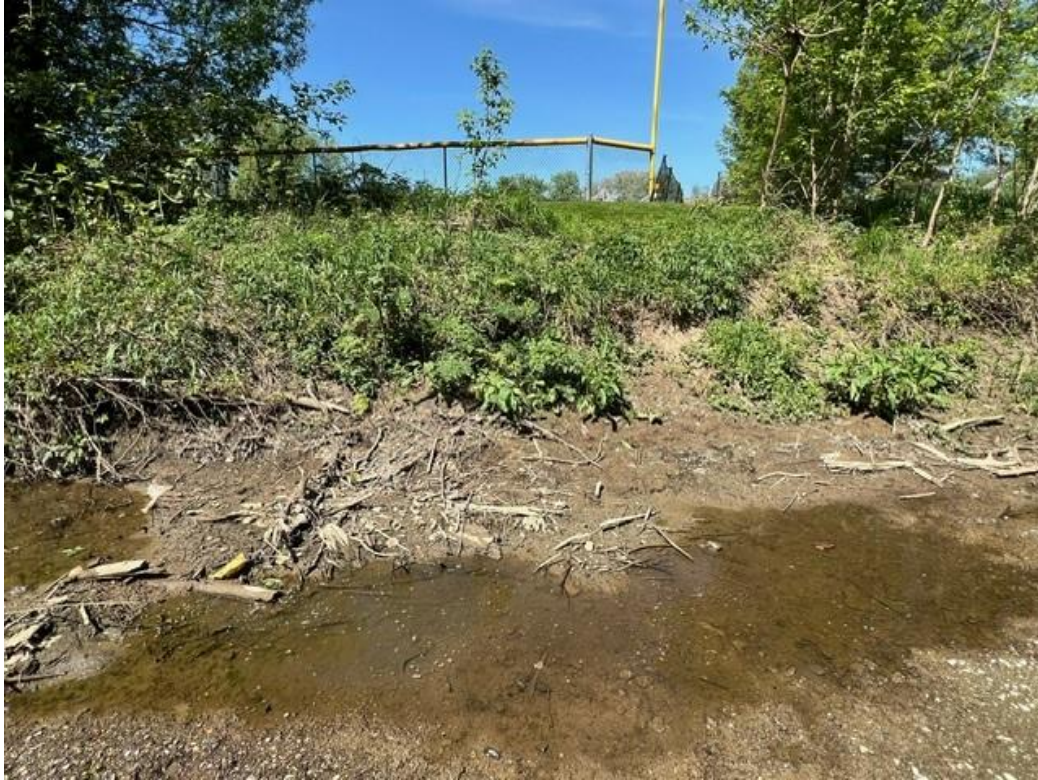
During the year of study, erosion was measured at all three subsections. This data backs up visual evidence of erosion, such as exposed roots and crumbling banks, seen throughout the length of the park. Importantly, five of the six pins located in subsection C were washed out during the winter or early spring, indicating that this area experiences the most erosion and should be prioritized for streambank stabilization. Visual evidence of the erosion is shown when comparing the photos from April 2023 (Figure 2) and May 2024 (Figure 8). Significant flooding occurred at the site in early April 2024 (Figure 9). Imaging from the Pennsylvania Flood Risk Map (Figure 10) shows that the Houston Ball Field is a regulatory floodway, which is defined by FEMA as the channel of a river or other watercourse and the adjacent land area that is reserved from encroachment in order to discharge the base flood without cumulatively increasing the water-surface elevation by more than a designated height. Accordingly, FEMA states that communities must regulate development in these floodways to ensure that there are no increases in upstream flood elevations. It is predicted that the severity and frequency of flooding events will be amplified due to climate change (Easterling et al., 2017). Therefore, it is crucial to take proactive steps now to stabilize the already eroding stream bank at the Houston Ball Field.

Figure 8. Erosion at subsection C, shown on May 3rd, 2024.

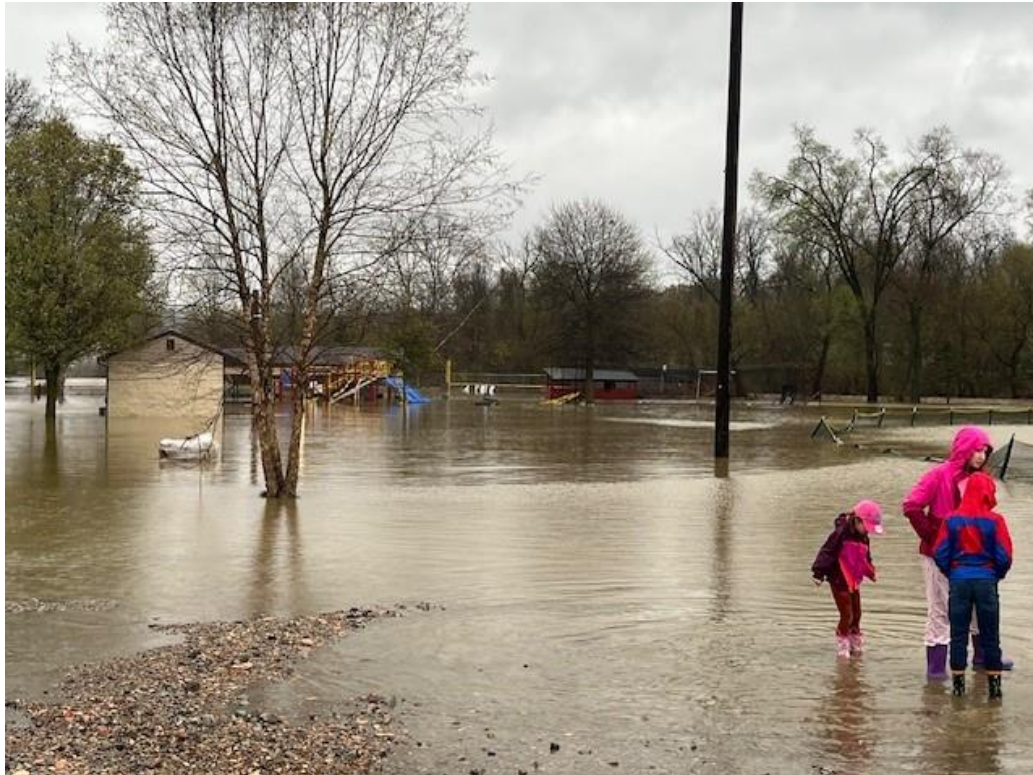
Figure 9. Flooding of Houston Ball Field in April 2024.

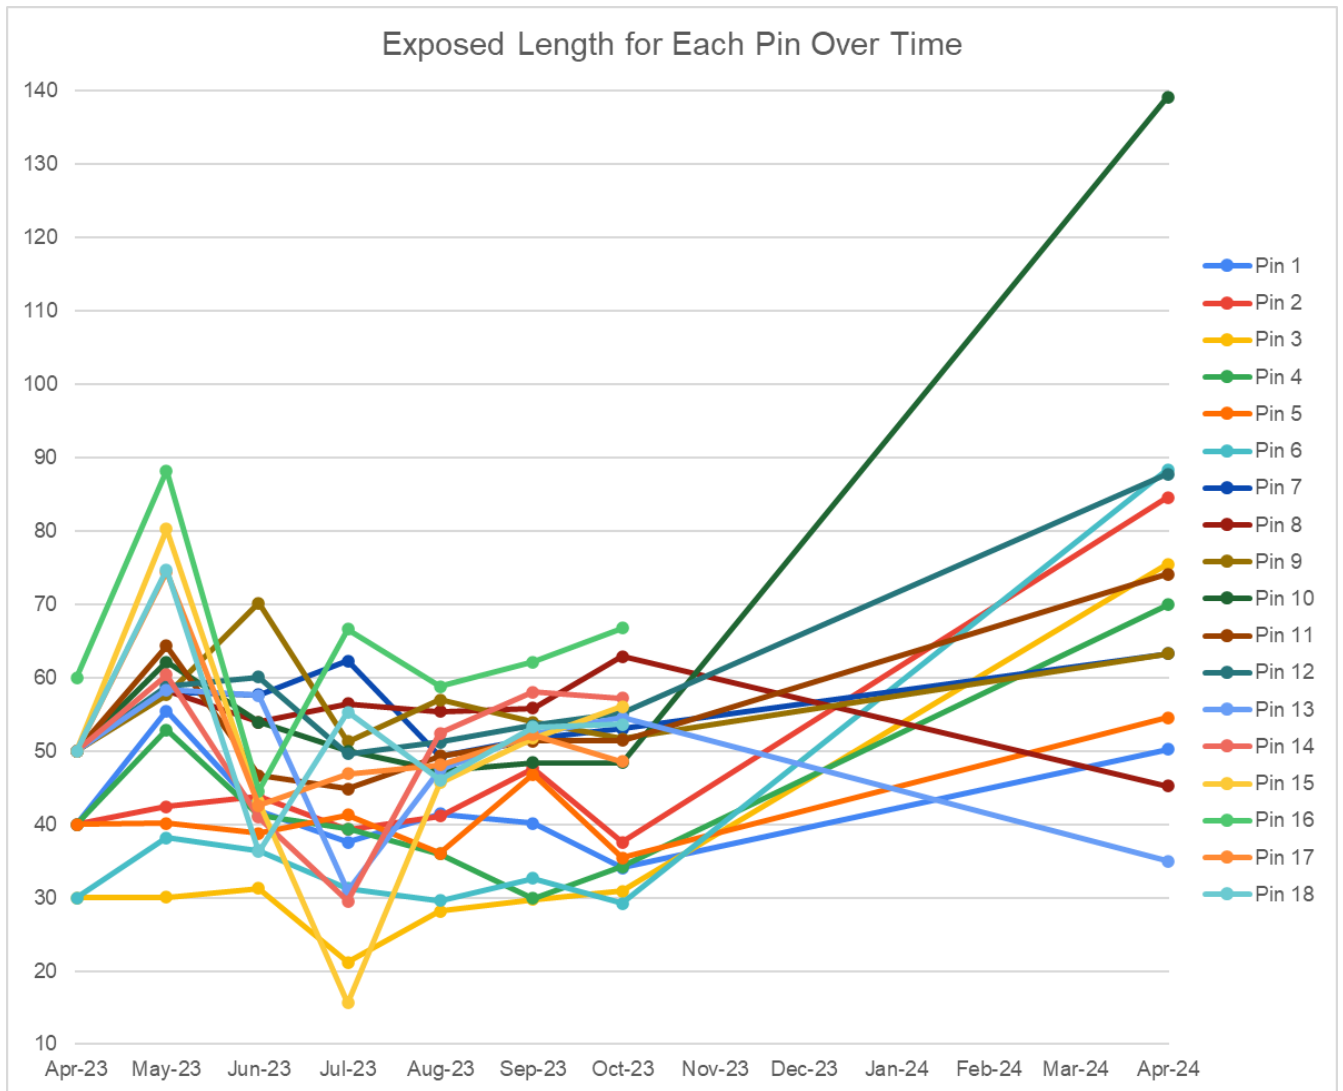
Figure A1. Graph of individual exposed pin lengths over time. An increase in exposed pin length indicates that erosion occurred.
