Houston Ball Field

Erosion Study Final Report

Chartiers Creek
Houston, PA

Prepared by the West Virginia Water Research Institute

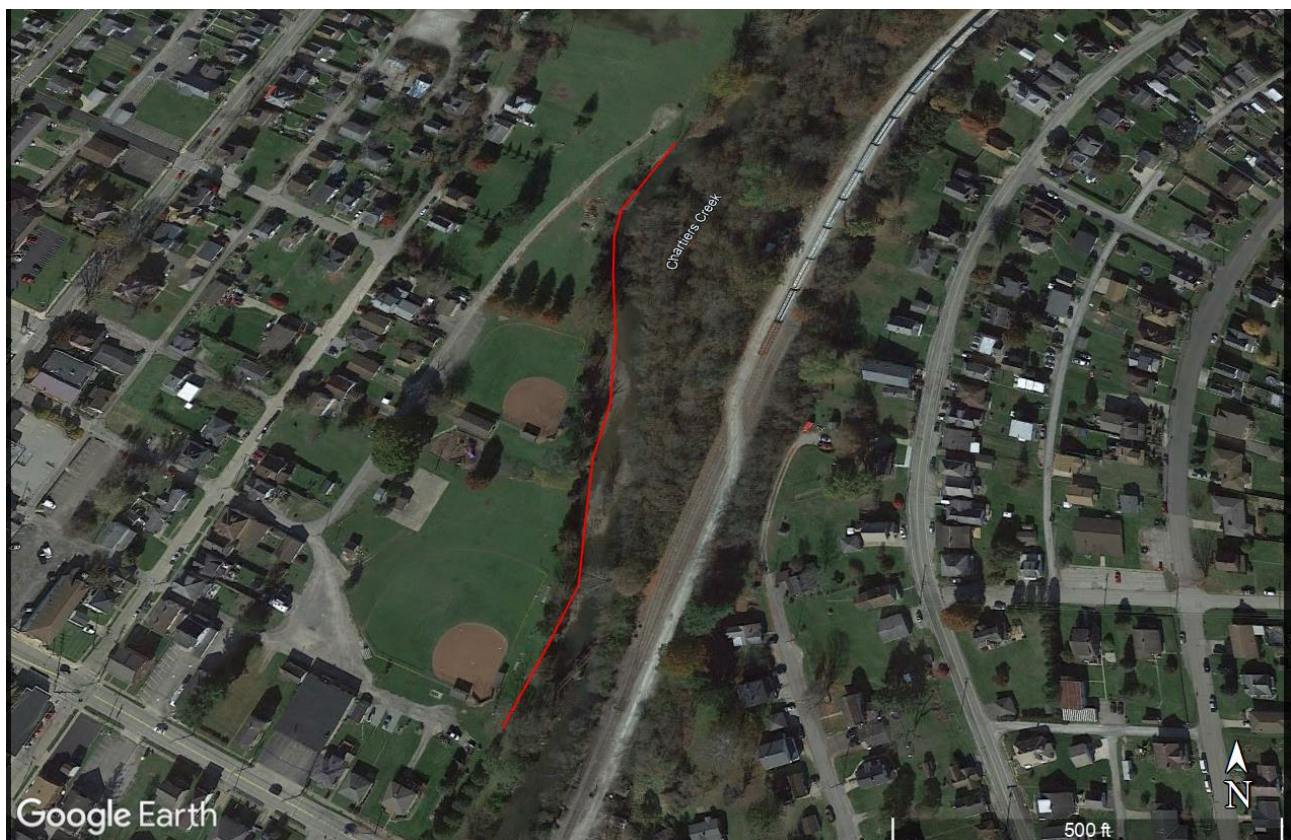
Figure 1. Reach of Chartiers Creek targeted for streambank stabilization.

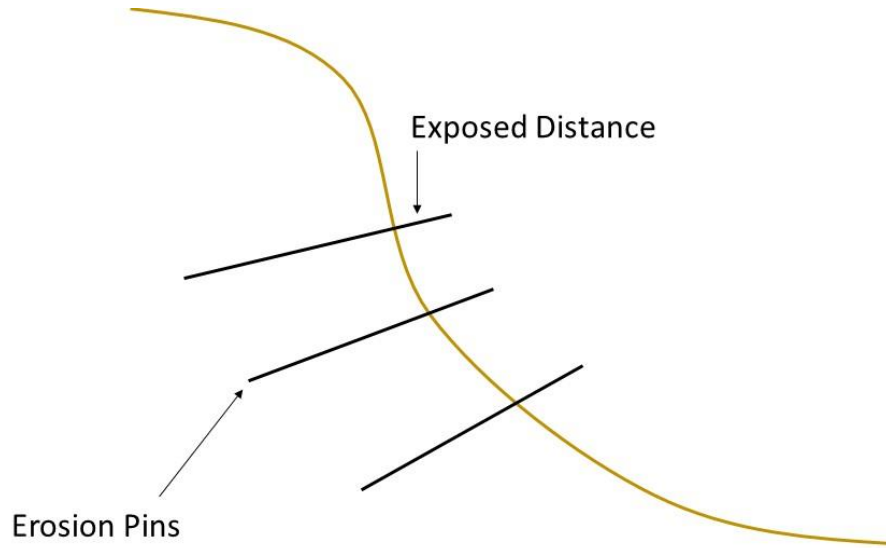
One-foot length stainless steel tubing (3/16" diameter) were utilized for the pins. Pins were installed perpendicular to the bank surface with an initial exposed distance of 3 – 6 cm (Figure 3). The exposed distance was greater where vegetation was dense, so that the pins could be found. The initial exposed length for each pin can be found in the field sheet in Appendix A. The exposed portion of all

Figure 3. Cross section of streambank demonstrating pin insertion.

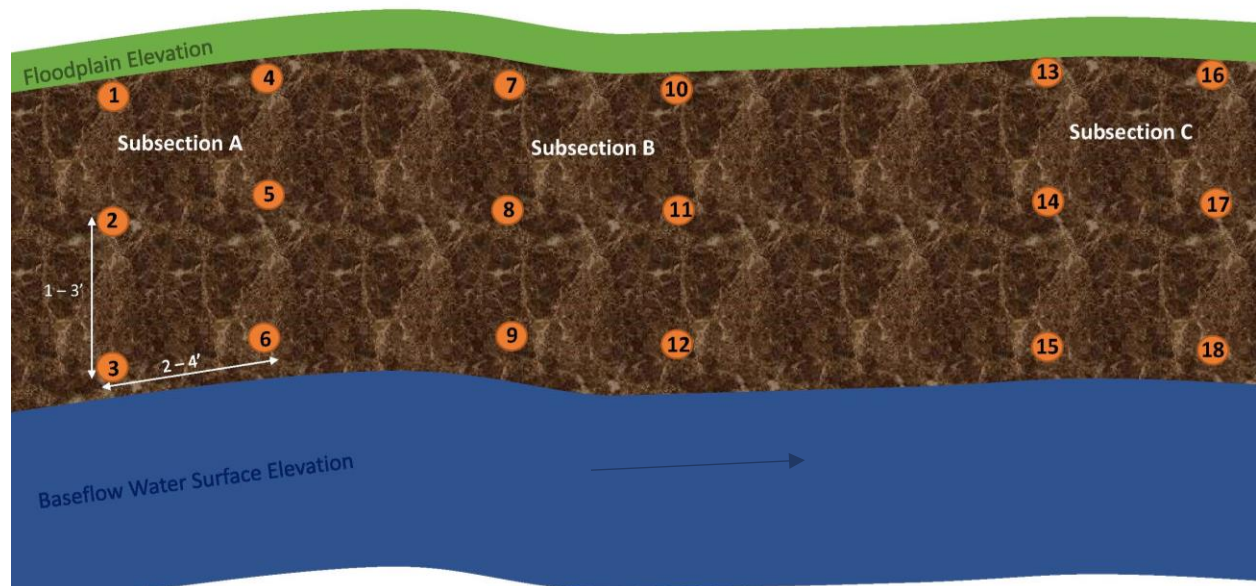
Figure 4. Pin layout overview and labeling from 1 - 18.

Pins are referenced via their assigned number from 1 – 18 following the layout in Figure 4. Pins were installed on April 20th, 2023, and the first measurement was collected approximately 4 weeks later during the volunteer training on May 15th, 2023. Measurements were collected during installation to record bank height and pin spacing. GPS location of the 3 subsections was also recorded and can be found in Table 1.

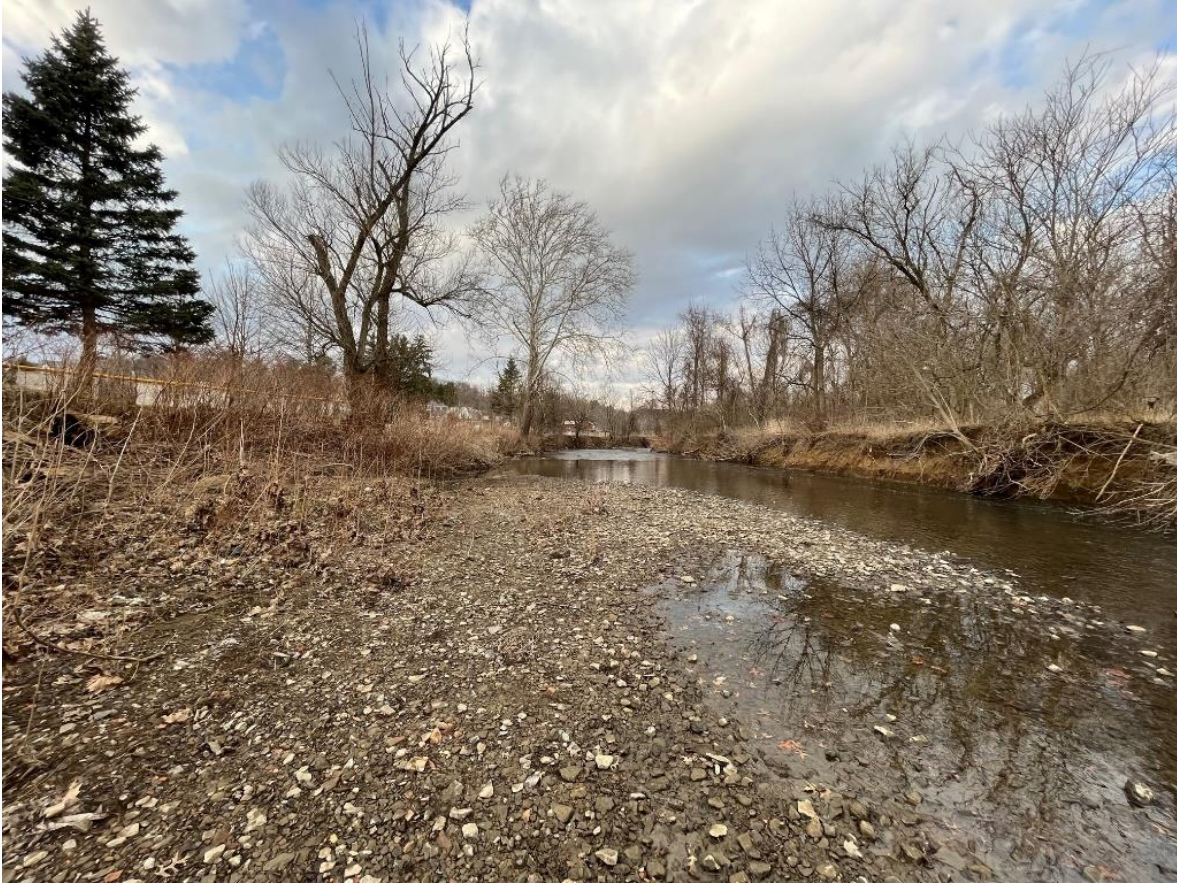
Volunteers accessed the stream in the area shown in Figure 5, then walked to each pin transect, where they measured each pin's exposed length. Measurements were taken utilizing a high-precision 15-cm digital caliper (Fisher Scientific), from the pin end to the bank surface at the vertical centerline along the downstream side of the pin (parallel with the stream) until contact was made with the soil surface and slight sediment movement was observed without compaction. If the total distance was greater than 15 cm, a temporary marking was made at 15 cm and a second measurement was collected from that mark to obtain the total distance. After measurements were recorded, pins were reset to their original length indicated in the field data sheet. However, pins with changes of less than 10 mm were not reset to minimize disturbance and error. Those pins were reset in subsequent months once the total change was greater than 10 mm, as compared to the original exposed length. Pins buried due to deposition were noted on the field sheet continuously until they became exposed again. In the event of a mass failure (a section of the bank sliding into the stream) or other cases of pin displacement, photos and notes were taken, and the pin was reset in a location as close to the original location as possible.

Figure 5. Accessible slope to the stream.

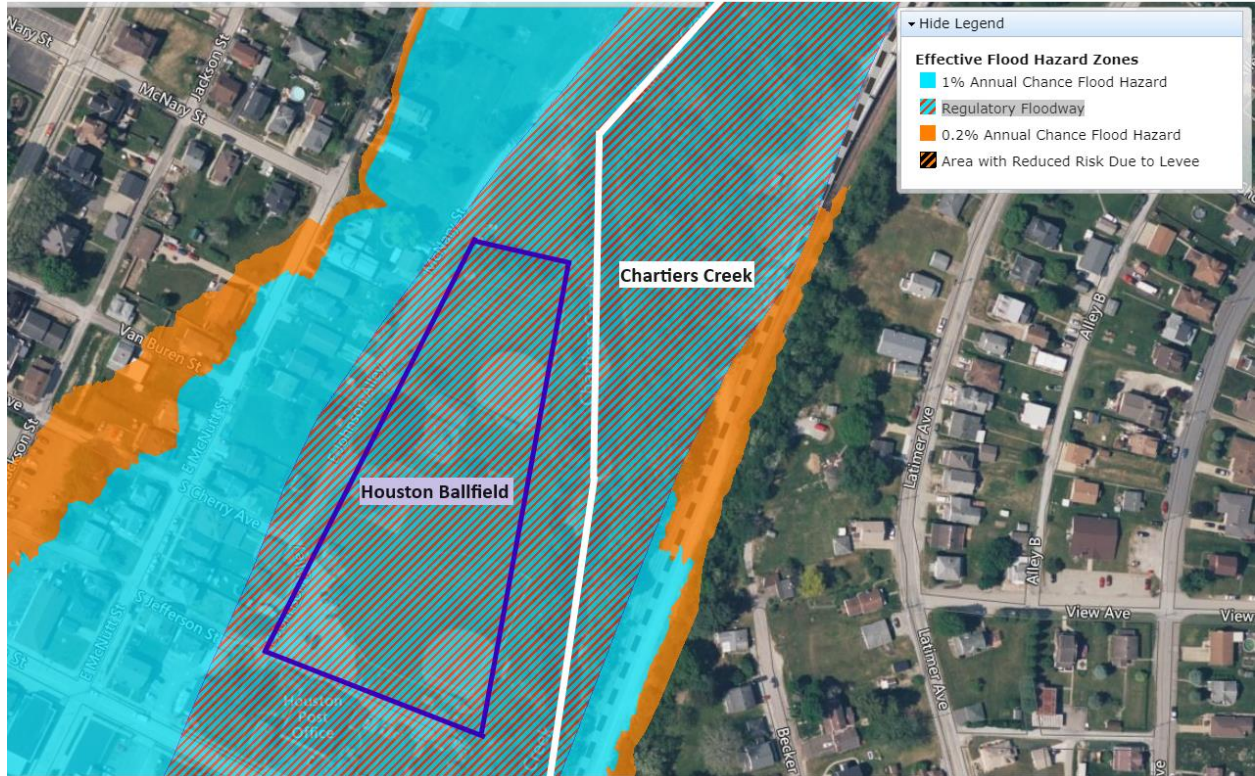
Figure 10. PA Flood Risk of the Houston Ball Field and surrounding communities.
